\* \* \* \* \* **SAFETY ALERT** \* \* \* \* \*

April 11, 2009

**Attention owners of Scamp 16' or 19' models**

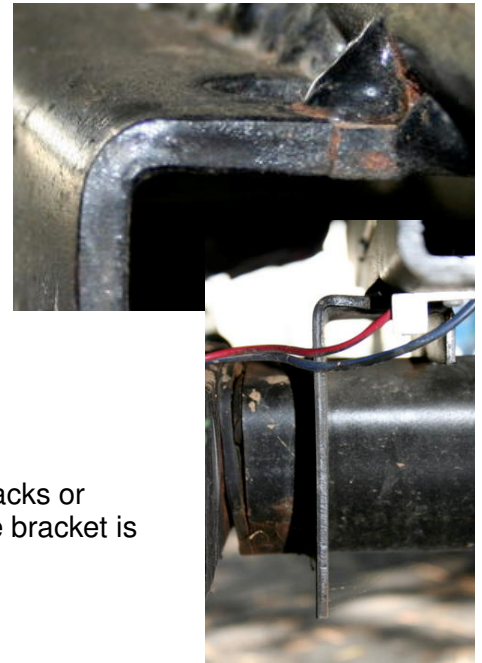
From the axle failures reported to date the initial cracks were consistently located along the edge of the welds as shown here enlarged (right, above). These photos were taken from the road side of the trailer. The curb side was a virtual mirror image. Both cracks extended into the rear bolt-hole slot.

The wider view photo (right, below) shows how the bracket was bent slightly. All angles should be 90 degrees.

The geometry of the weld bead likely plays an important role in crack initiation. The fillet weld shown here (above) is concave. Note the shape of your welds, and photograph if possible.

Damaged axles should be reported to Scamp Trailers (800/346-4962). Even if your trailer is out of warranty, this is a safety issue. They will provide instructions for next steps.
